Metal Surgery Milwaukee, LTD.

PTO Quill Shaft Repair

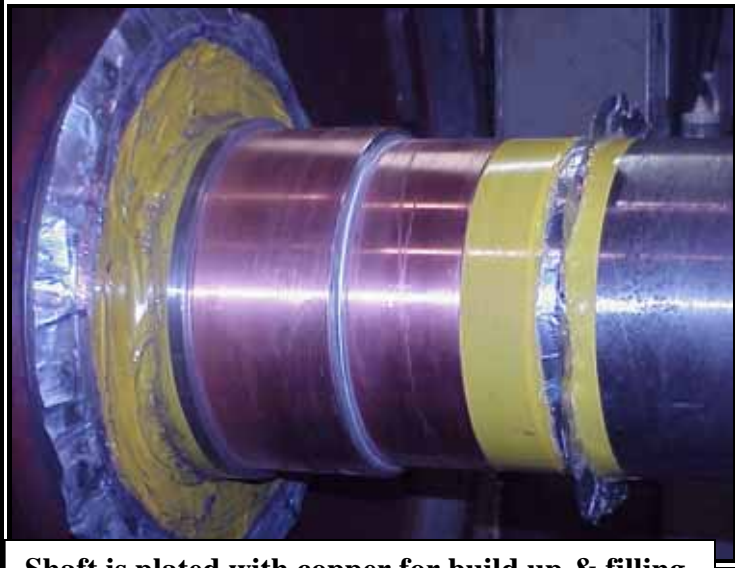
Shaft is plated with copper for build up & filling gouges from bearing failure. Also prepared for nickel plating

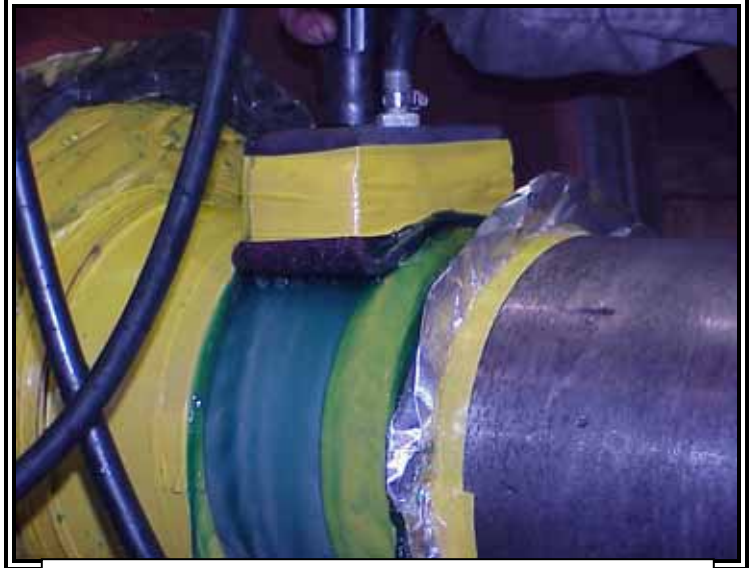
Using a flow through anode nickel plating is in process.

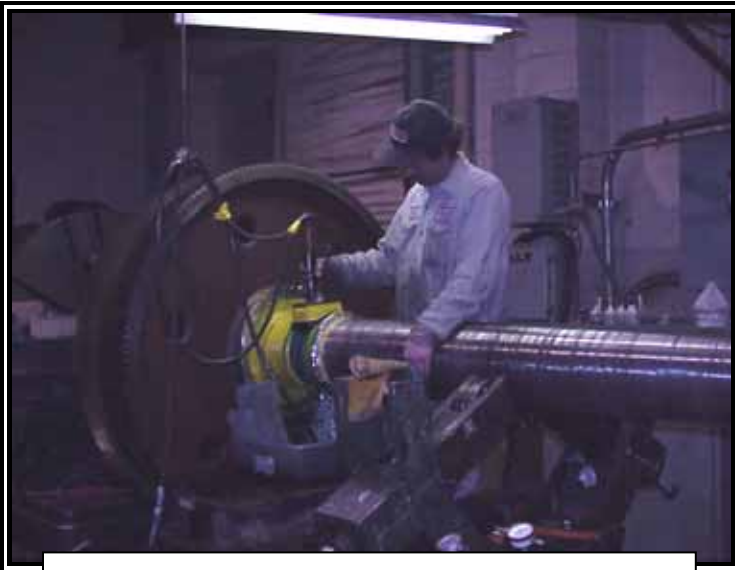
The quill shaft is set up in a lathe for rotation during plating process to obtain a uniform build up.

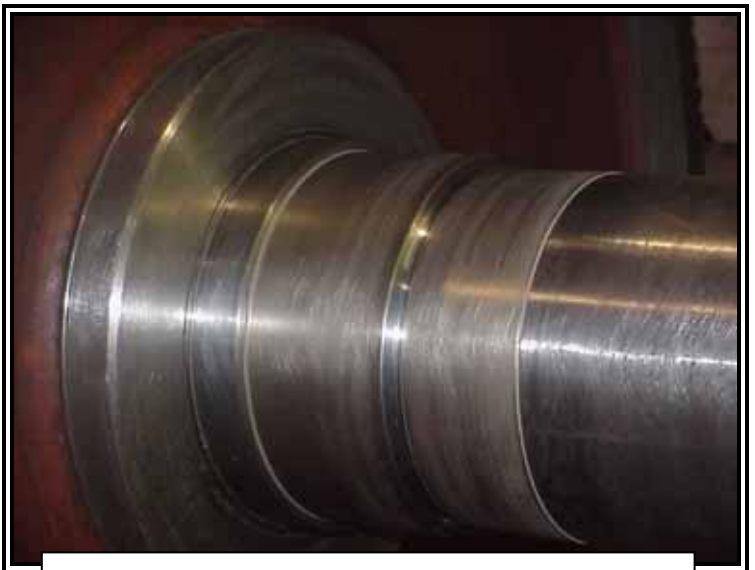
Plating repair is inspected & completed to Mfg. specifications.
