Metal Surgery Milwaukee LTD 182 W. Oklahoma Ave. Building #23

PLATING CUMMINS ENGINE BLOCK ON-SITE

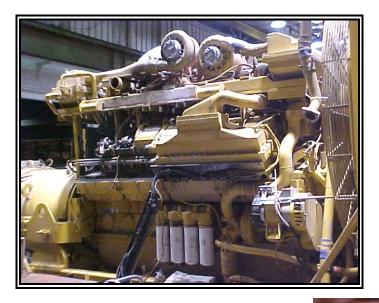
MINIMAL DISASSEMBLY IS REQUIRED IN REPAIRING THIS 16CYL CASE. (LEFT)

EROSION OF LOWER SLEEVE BORE RESULTS IN LEAKAGE FROM WATER JACKET. (BELOW)

(Lower left) ERODED AREAS ARE COPPER PLATED FOR BUILD UP.

(Lower right) COPPER PLATING WAS HAND FINISHED & PLATED WITH NICKEL TO MFG. SPECS. COMPLETING REPAIR.
