Metal Surgery Milwaukee LTD

NORTHERN ENGINEERING DIVISION OF FRASER SHIPYARDS INC.

This 14-foot PTO quill shaft was damaged on bearing journals and seal diameters due to bearing/seal failure. Repair procedure consisted of re-cut centers; under cut to remove worn & total indicated run out on 4 different surfaces. Copper plate approx. .01 per side, machine, nickel-plate & grind to Mfg. specifications.

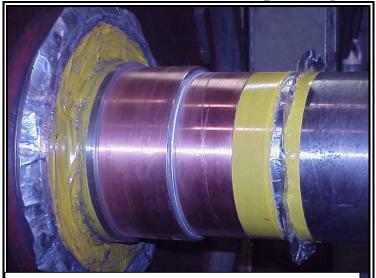
Shaft is plated with copper for build up & filling gouges from bearing failure. Also prepared for nickel plating

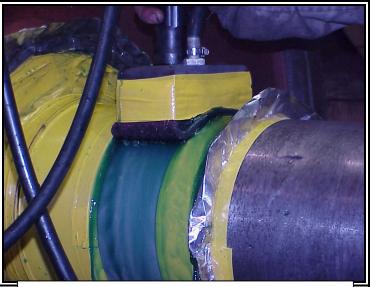
Using a flow through anode nickel plating is in process.

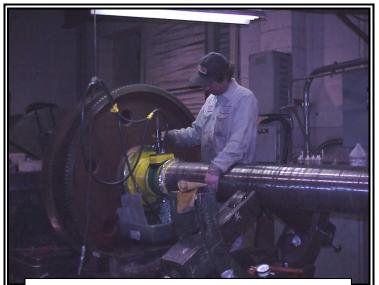
The quill shaft is set up in a lathe for rotation during plating process to obtain a uniform build up.

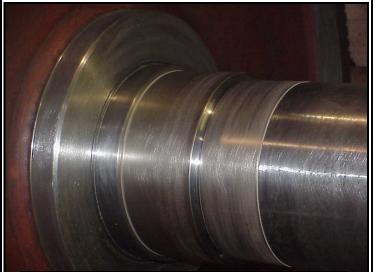
Plating repair is inspected & completed to Mfg. specifications.
