METAL STITCHING

Metal Surgery Solves Puzzle of the Broken Gear Box

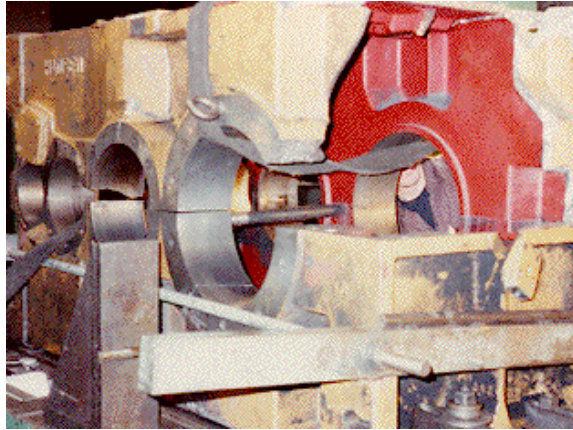
Operation on this conveyor system was humming along when suddenly the chain climbed the sprocket on this Hanson gear box. The shaft tore loose and proceeded to self-destruct. Plant operation was brought to a dead stop at a cost of \$300,000 per day..

Hanson gear box is in nine pieces upon arrival to shop.

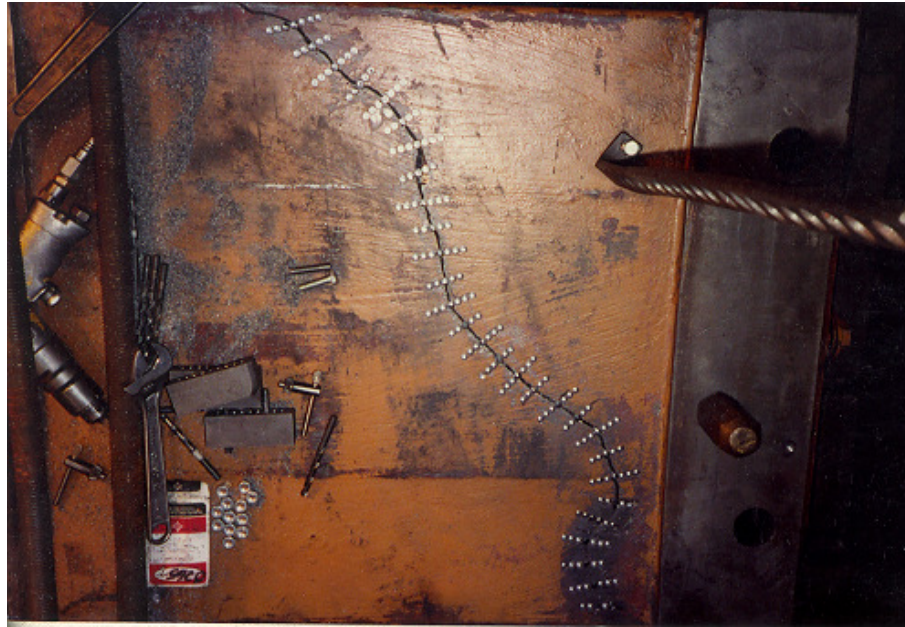
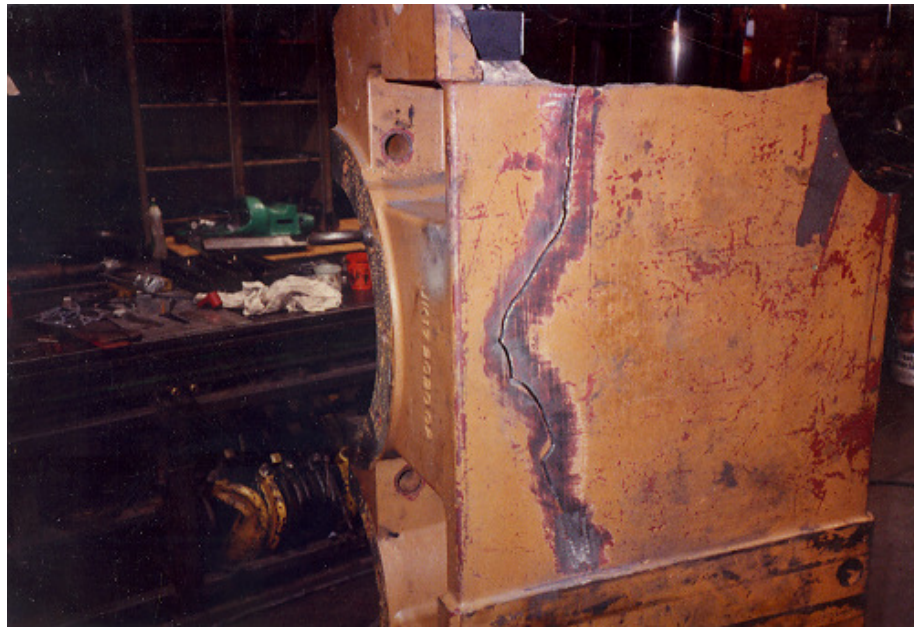
View show the extent of the repair on the housing.

*For the completed repair; no machining was necessary.
Procedure saved owner considerable downtime as a new gear box would not be available for nine months.*
