Metal Surgery Milwaukee, LTD.

Pinion Gear Repair

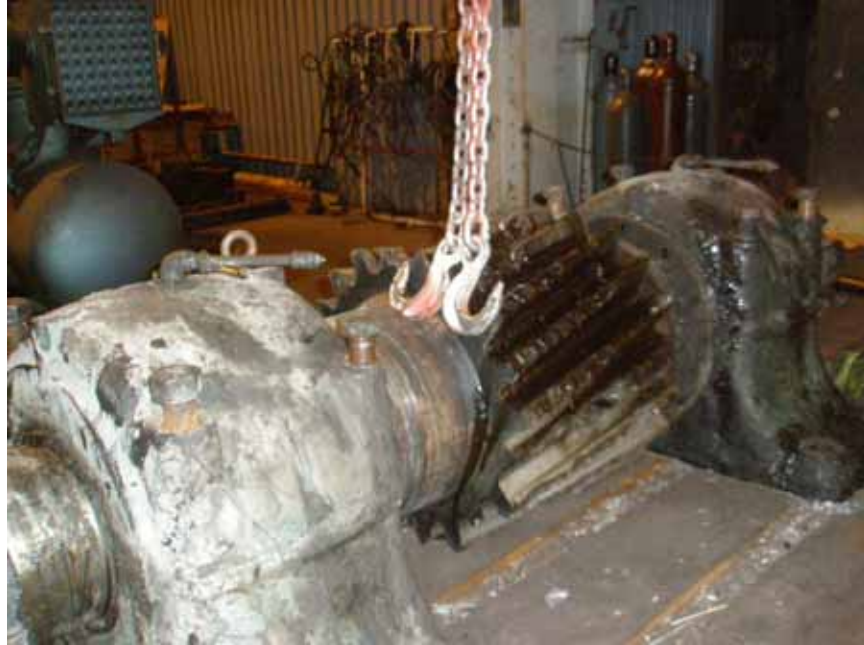
Pinion Gear Assembly

Gear failed during production. (No spare, EMERGENCY repair)
Disassemble pinion assembly, repair teeth by welding, machine and hand finish teeth; and reassemble.

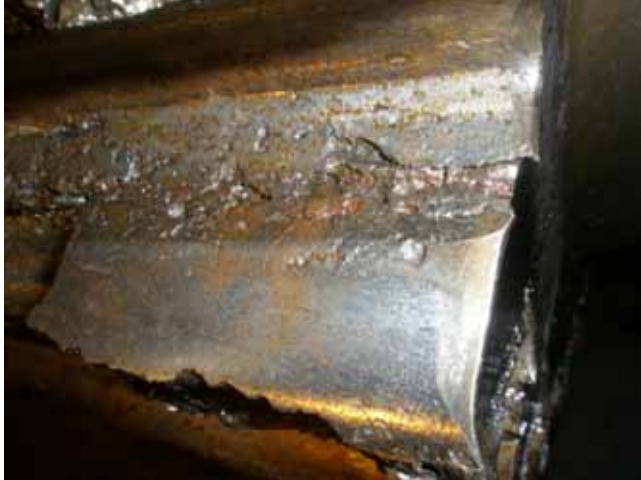
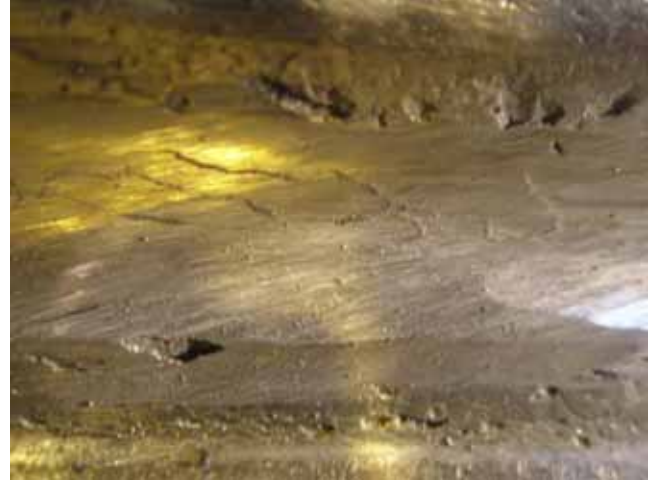
After all the cracks were removed, there were not many teeth left. The base material was analyzed and a weld procedure was produced.
