Metal Surgery Milwaukee LTD.

Kiln Gear Repair 19'6"

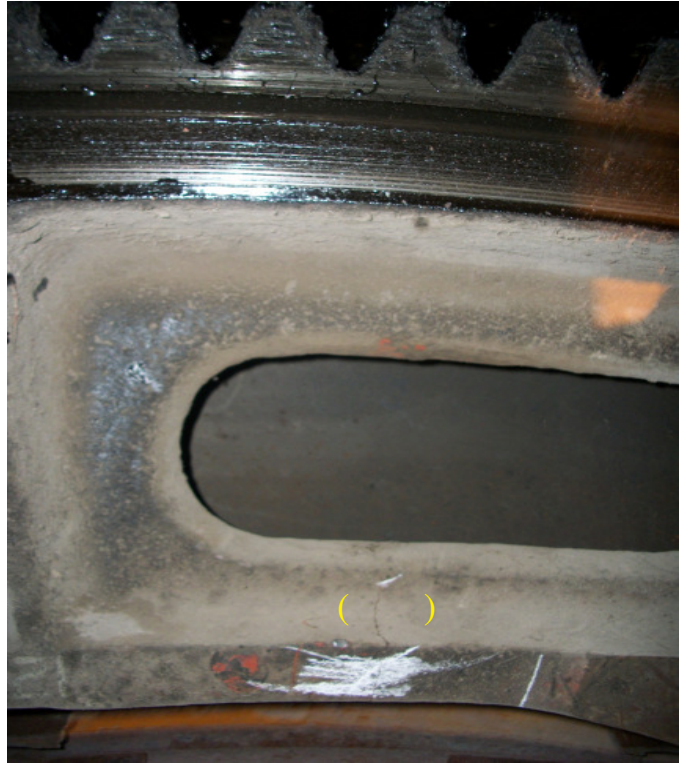
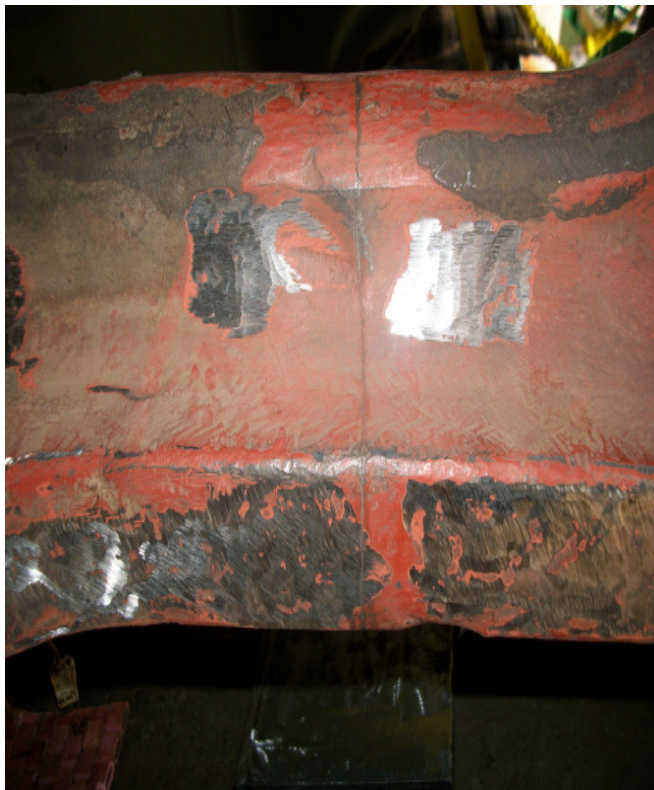
The main rib was cracked in half. This view shows the location of the crack and approximate size of the rib is 6 inches wide at the bottom and 5 3/4 inches in height.

When the layer of cement was removed you could see the rib was cracked all the way through. All paint was removed around the repair prior to any work commencing on the rib. A one inch thick steel plate was installed on the bottom of the rib approximately 8 inches wide by 10 inches in length. This was clamped on and tac welded in approximately 6 places, then the heating equipment was installed. The steel 8 inch wide plate gave us a 1 inch overhang on each side, which was also used as a run-off tab during welding. Most important of all, this plate secured the alignment of the rib during excavation of the fracture.

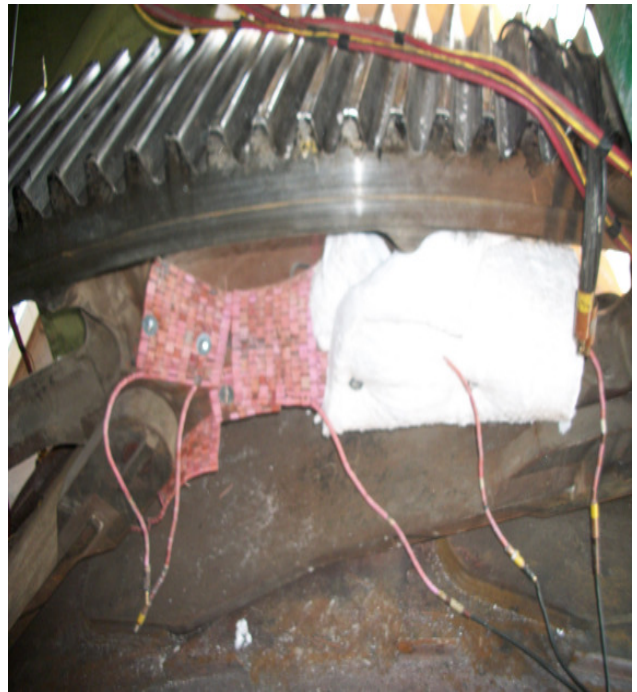
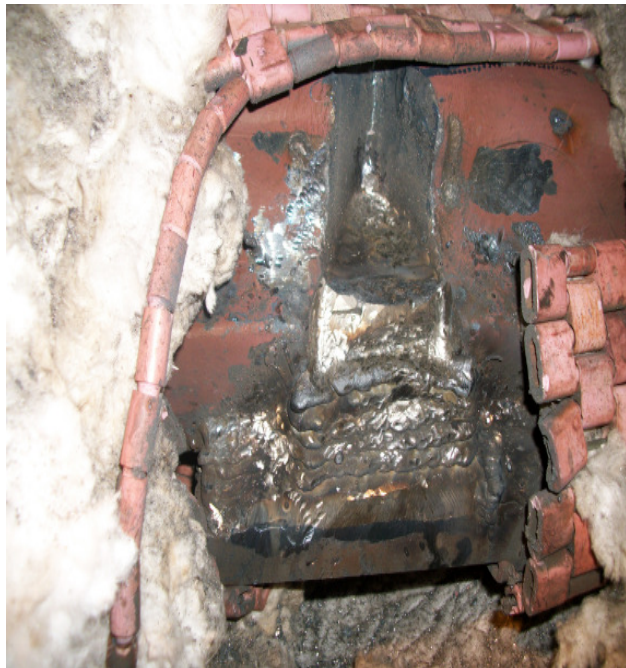
The ceramic pads, kao wool and thermo-couplers were installed all around the repair area to heat and monitor throughout the repair and document by a computer generated graph. The gear was then slowly heated by procedure

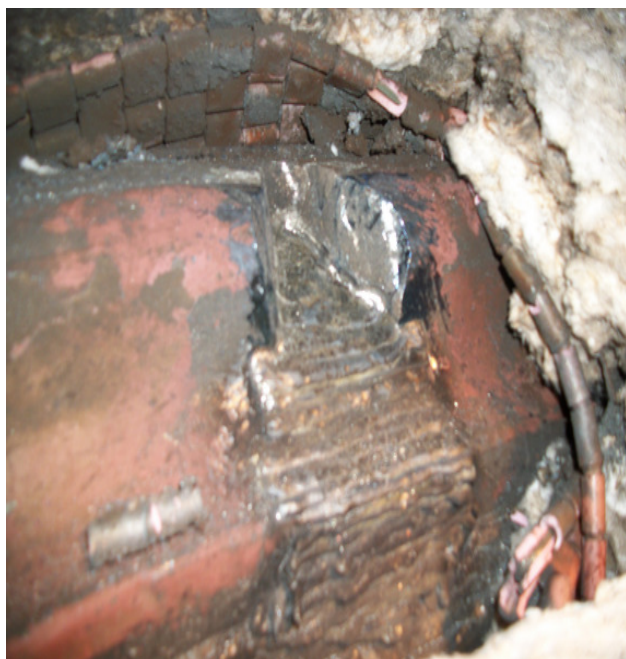
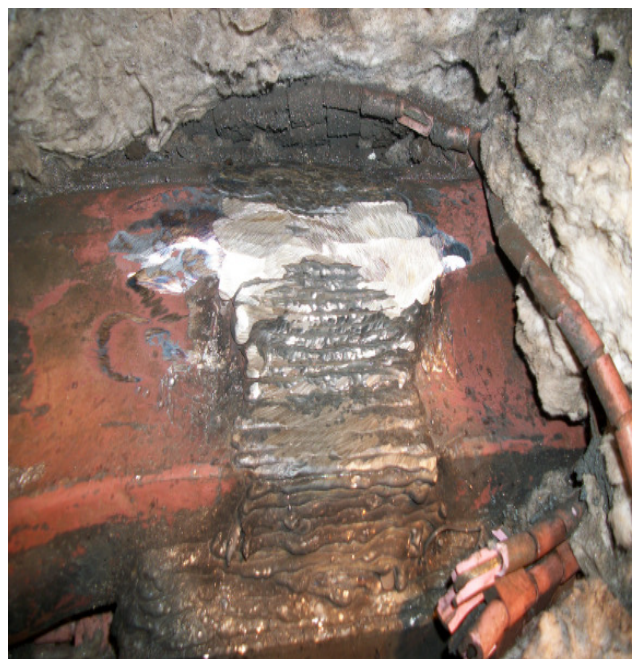
This repair was done in three stages, clean, inspect and secure. Stage 2 was to excavate 50 percent, weld and reinforce. These pictures reveal the bottom plate welded on with a 1 inch fillet weld around perimeter and 50% of the rib excavated and welded in progression.

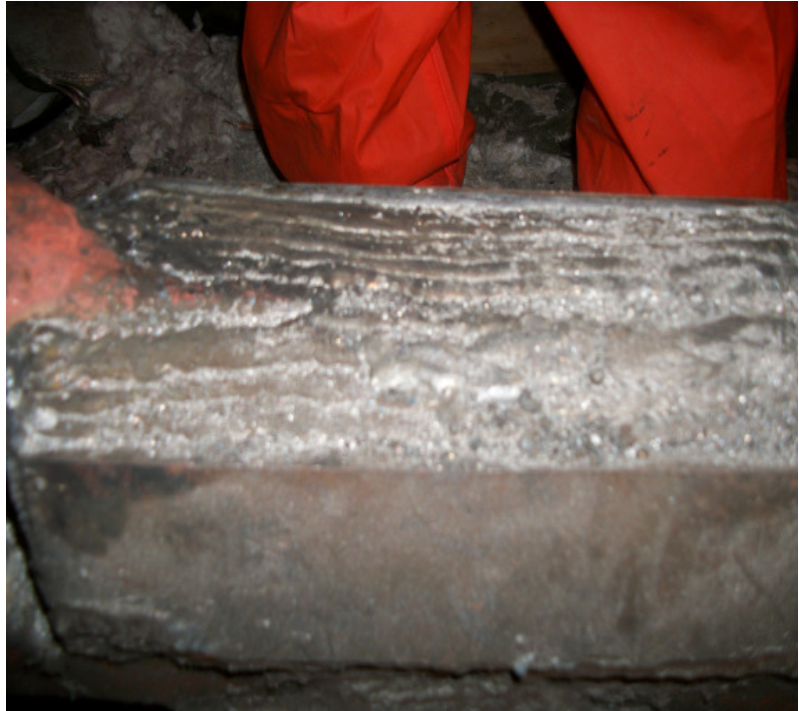
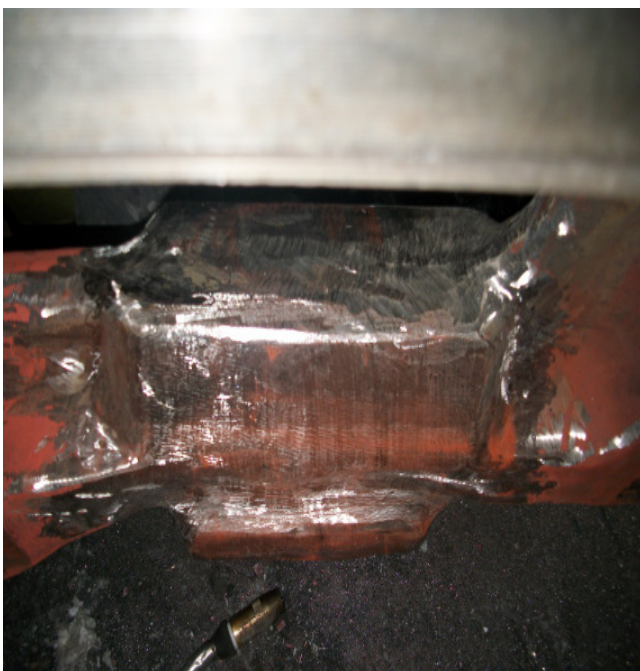
Stage 3 was to excavate and weld the remaining material plus 10 percent into the already welded section. Once all remaining fracture was removed by carbon arc, it was ground to bright metal, inspected and welded up 100 percent which included another reinforcing bar. The two side reinforcing bars were approximately 1 inch thick by 3 inches wide by 12 inches long. Once the repair was completely welded it was then stress relieved for 6 hours. It was then slow cooled to ambient temperature, M/S then hand finished the repair to contour. The repaired area was then mag particle tested 100 percent with no defects.
