# BRUSH PLATING

## Getting to Where the Gouges Are

*Wear and sea air had taken its toll on the plating on the plunger of this shipboard conveyor cylinder.*

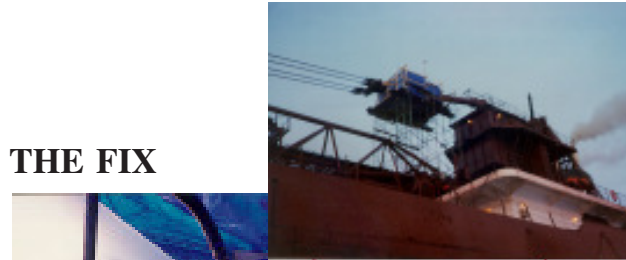
Lufting cylinder was located 60' above the main deck of this ore carrier for off-loading. Surface plating and gouges -- some as deep as 1/2" were found on the ram OD, resulting in tears to the seal. Standard procedure is to remove the cylinder for repair. To cut time and money, Metal Surgery decided to work on the cylinder in place. Work has started on the scaffolding platform for the repair to reach the cylinder 60' above the ore carrier's main deck.
