Metal Surgery Milwaukee LTD.

On-Site on Florida Coast Weld Repair to Engine Intake

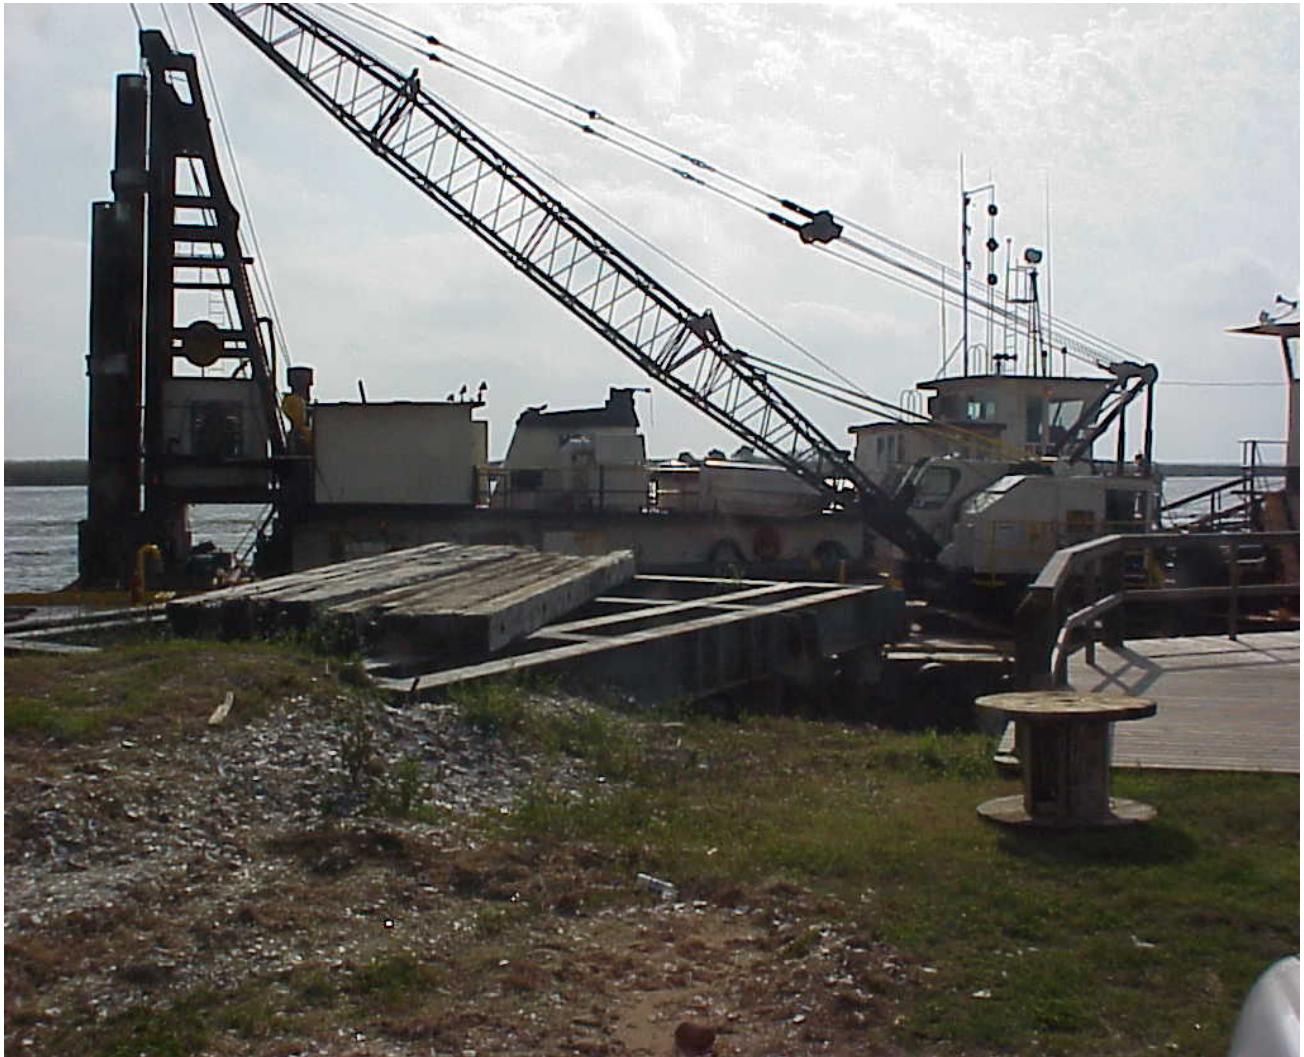
Metal Surgery was called upon to weld the inside of an engine on a dredge located in Florida on the intercoastal ways.

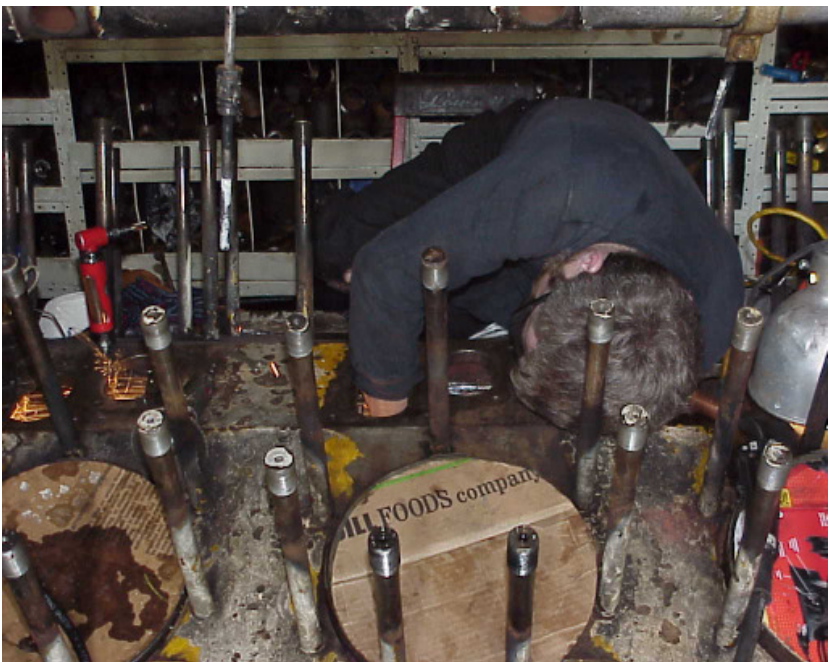
This picture shows the position that the repair man had to be in for welding a cracked seam inside the engine. The crack was located on the bottom of the intake, which is actually overhead for the man reaching through a 5” hole by 9” oval hole.

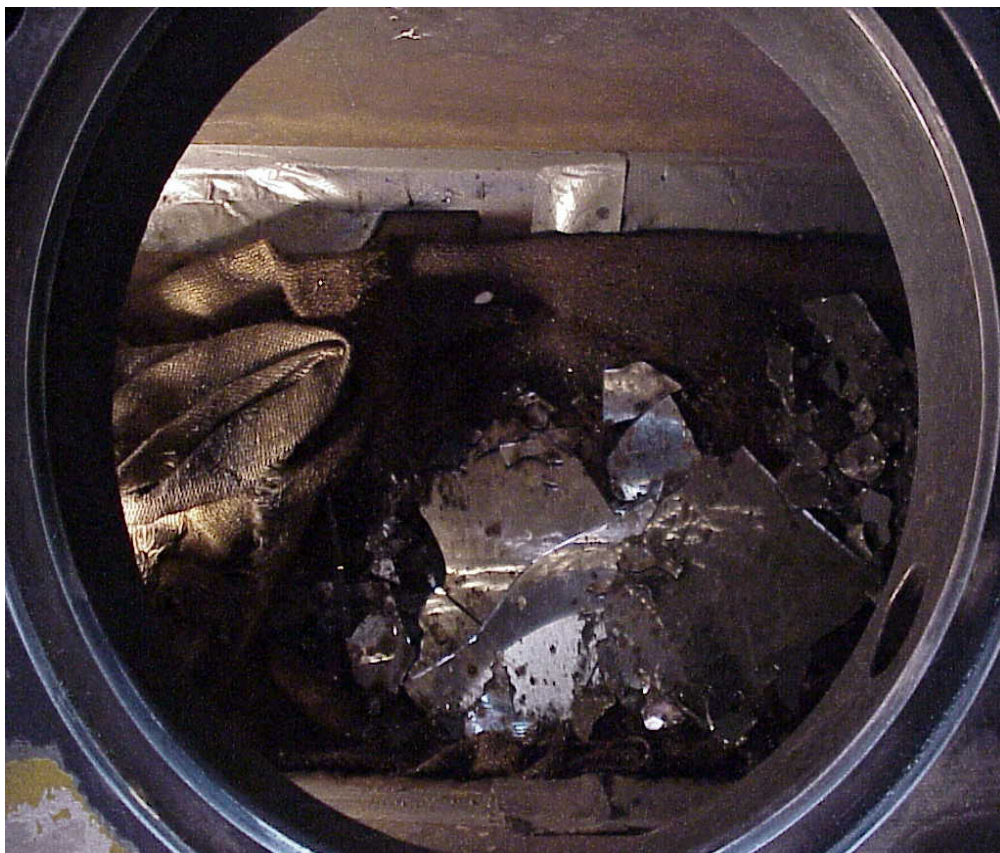
Due to the location of the crack, we had to use mirrors through the whole job. The crack was approximately 14” long. We went through over 30 large mirrors. Everytime weld or a stream of grinding sparks hit the mirror it shattered. Note the pile of mirrors in the bottom.

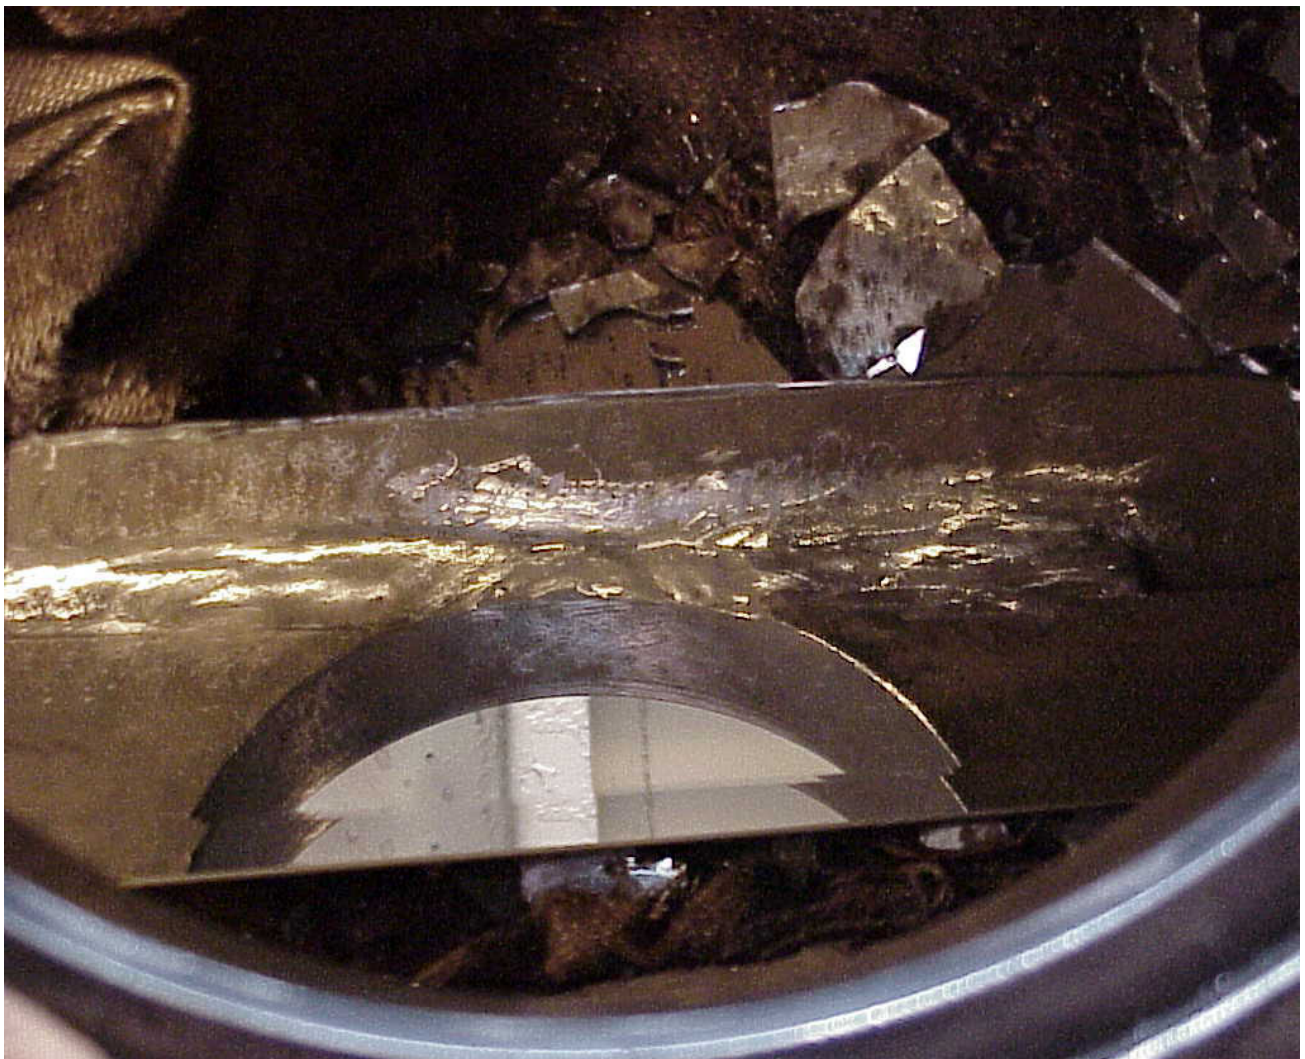
This view is looking at the actual repair reflecting off the mirror. There were many companies called upon to do this job. Everyone said it could not be repaired until Metal Surgery was contacted. (Another Success!)
