Metal Surgery Milwaukee LTD.

On-Site Flange Facing

Boiler Tanks

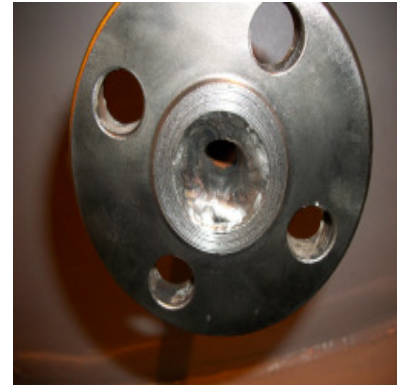
The picture to the right was a very small face in which we had to give a phonographic finish to. 1 11/16" face being very small, Metal Surgery had to customize an existing machine for the phonographic finish. No problem though for Metal Surgery, because we are very adaptable.

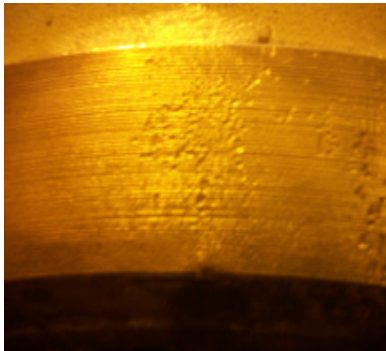
On the left was a 27" flange face. This face had many imperfections, some of which was damage. Metal Surgery Milwaukee LTD. made a clean up cut, then the phonographic finish cut. These repairs were made in minimal time allowing the customer to keep his shipping deadline.
