STITCHING

Process Cuts Repair Time from Months to Just Weeks

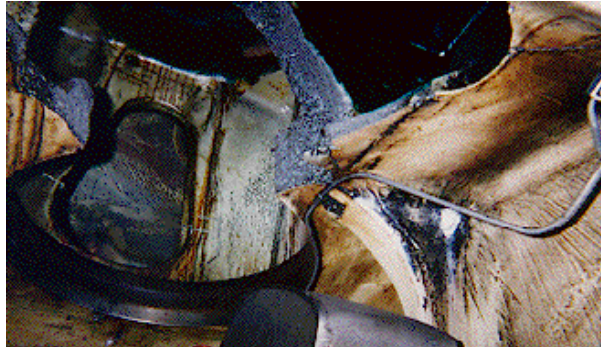
Out at sea, the crew of this Russian container ship noticed a sudden loss of power. Upon inspection below, they discovered the engine had thrown a conrod causing severe damage to the engine block.

Cracked sleeve seat area.

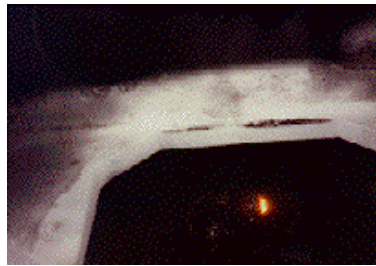
Fractured iron is removed, template is made to fabricate and machine two new cast iron inserts.

Metal Surgery inspected the damage in Vladivostok. Back at the shop, two inserts were fabricated and machined. Metal Surgery then shipped men, equipment and the inserts to Seattle to meet the ship and engineer the repair.

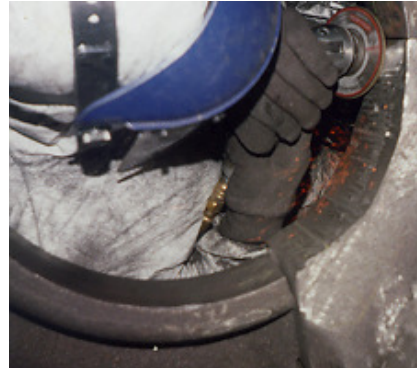
New inserts fitted and installed. Stitching is in progress.

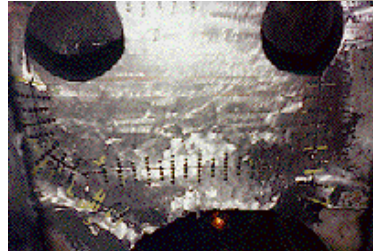
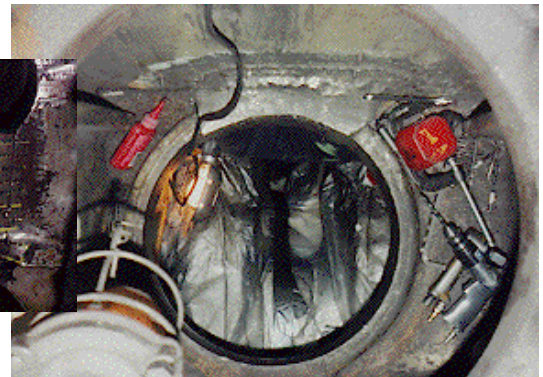
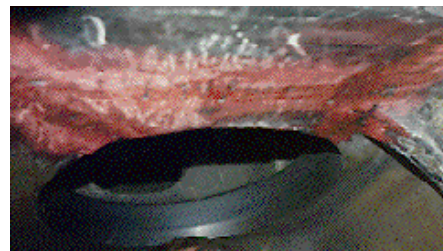
Stitch repair and machining completed on the inserts. This repair took 16 days while the ship was under half speed, yet proceeding to its destination with a full cargo hold. Estimated engine block replacement would reach

approximately \$3,000,000 with three months of downtime. The repair was five per cent of replacement cost with no downtime.
