METAL STITCHING

Self-Inflicted Crane Damage Repaired by Stitching

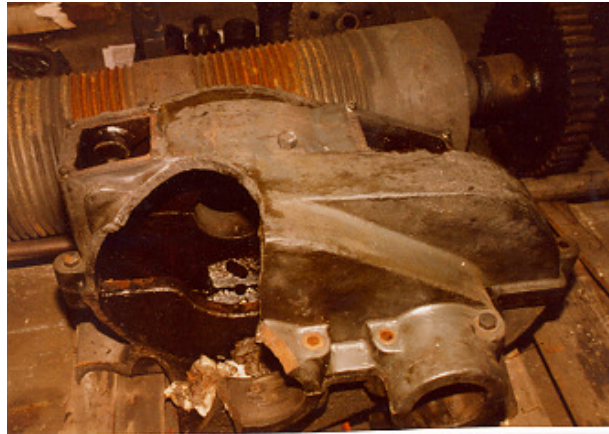
As a result of the crane hook accident, the gear box was broken into 13 pieces.
