Metal Surgery Milwaukee LTD.

Emergency Metalizing Of Shaft

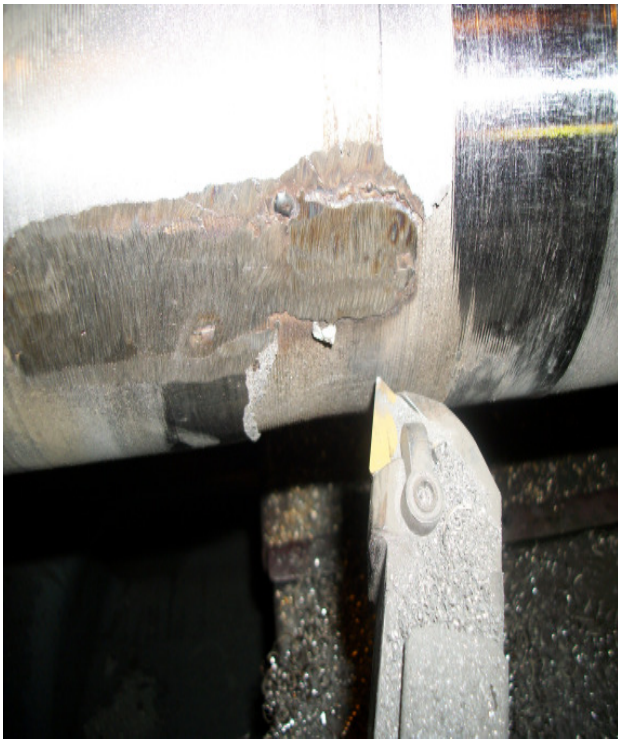
Metal Surgery cleaned the shaft's keyways to weld up complete upon arrival. Upon the shaft being cleaned, M/S then proceeded with the repair of the keyways. Due to a heavy deposit of metal spray being on the shaft already there was extra grinding to remove any deposits for welding of the keyways.

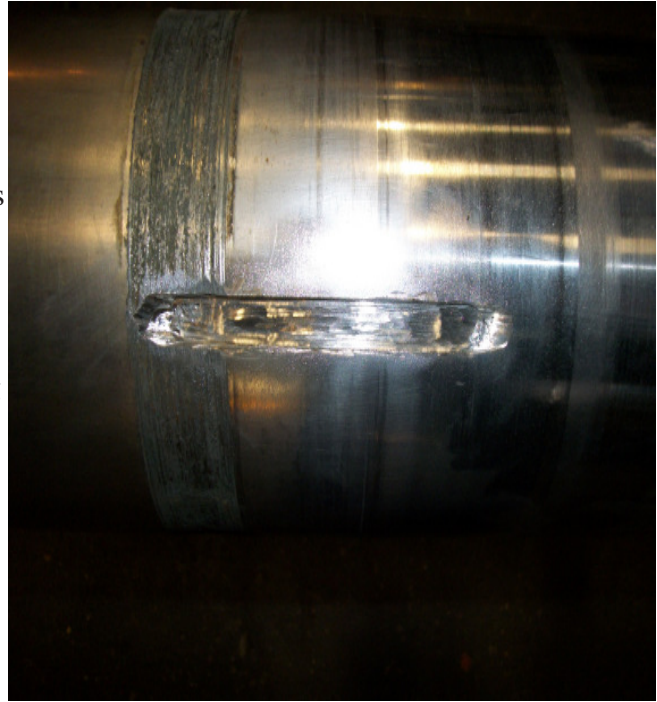
On the right illustrates all the old metal spray removed. The piece was then prepped for metal spray by blasting

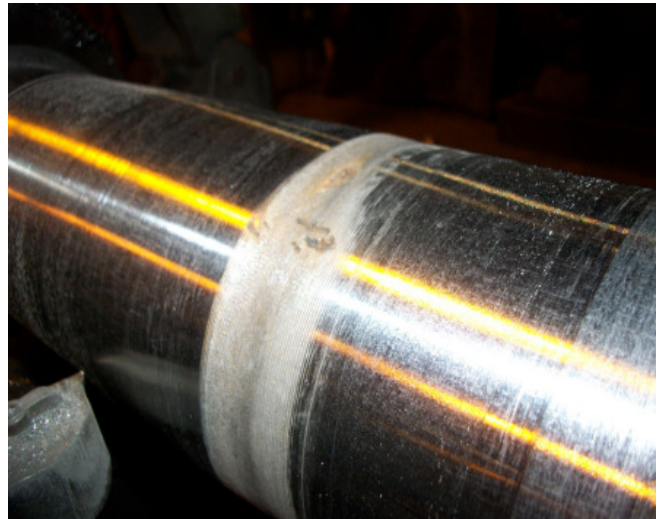
After the keyways were welded complete, the shaft was put on the machine and M/S proceeded to machine the old metal spray off the shaft. This was no easy task being that the shaft wall thickness was only .200" thick. The metal spray was .095" thick. This being said it was a very delicate process. Metal Surgery took extra precautions by ordering and machining a spare piece to be machined and welded on in case the piece was not salvageable.

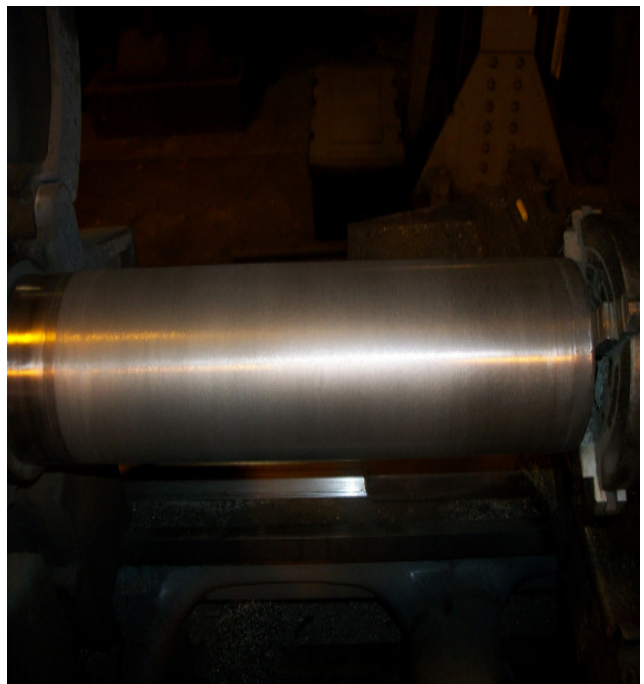
Spraying completed Metal Surgery then moved to machine the shaft back to the required size.
