Suction Roll Repair

Metal Surgery Milwaukee LTD.

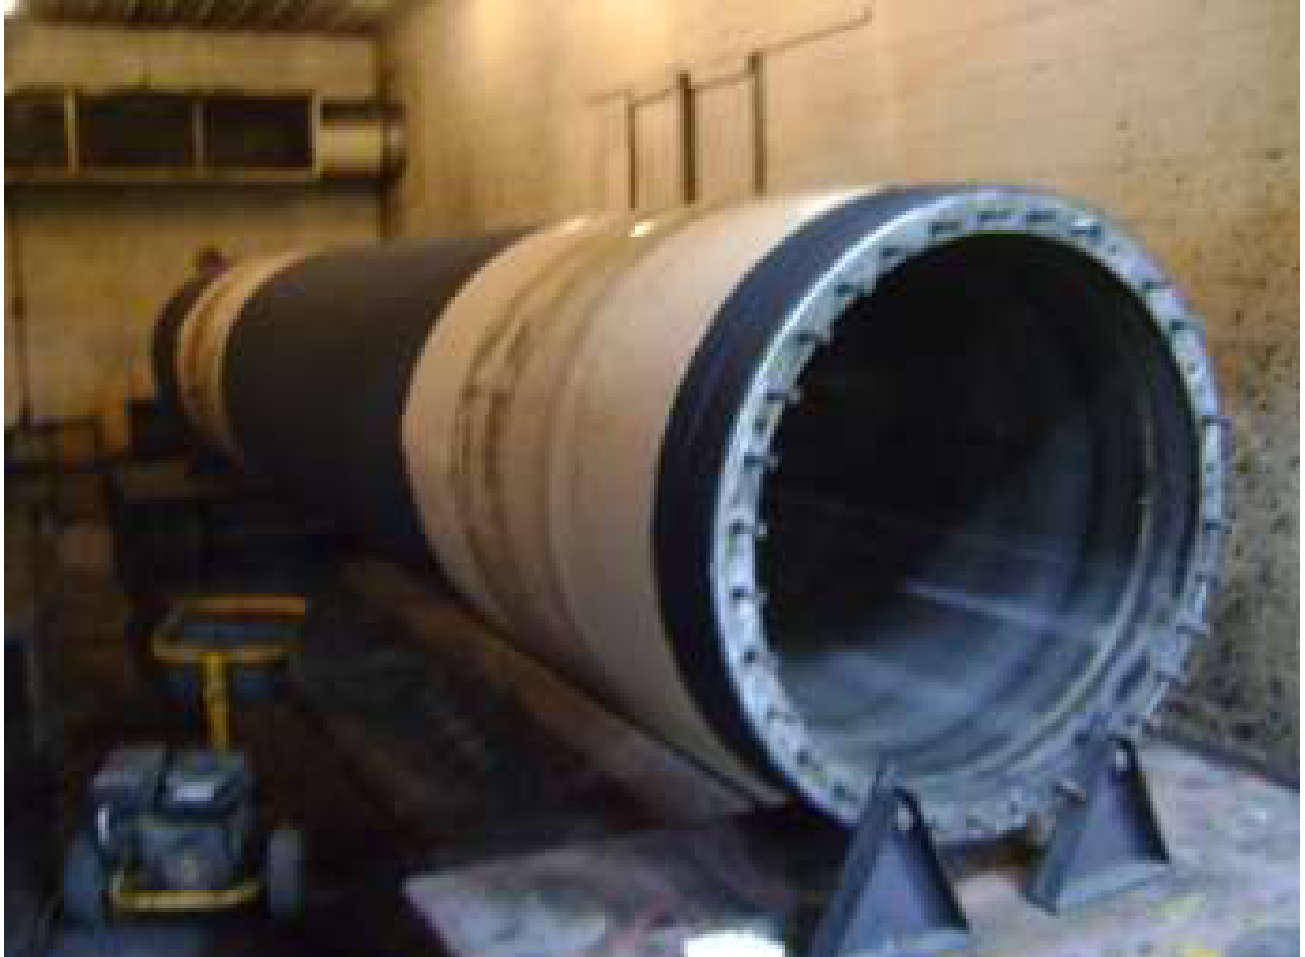
Metal Surgery was called when this suction roll was found to have two cracks on the inner diameter. Being a special alloy, a special welding wire was ordered for this repair in addition to using a pulse welder and a cooper heat machine to monitor temperatures.

On the right you can see extra precautions were taken to not contaminate the coating with grinding dust and metal shavings.

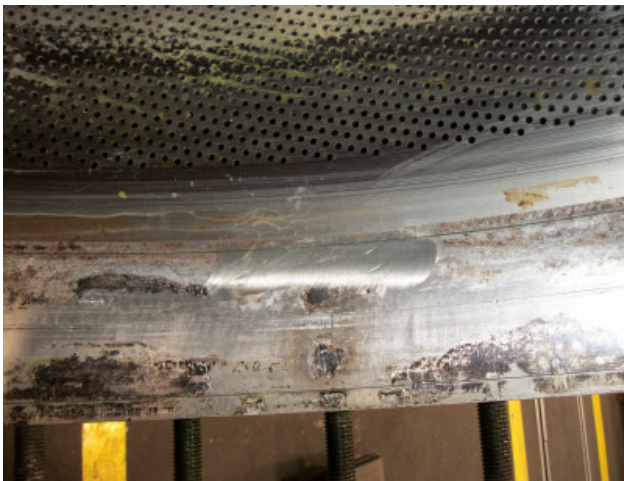
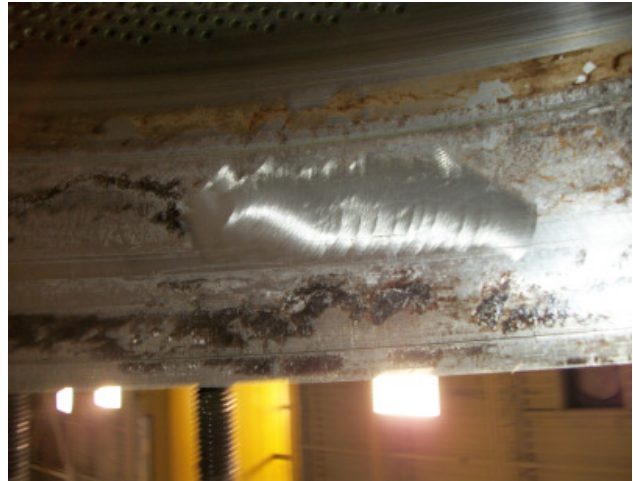
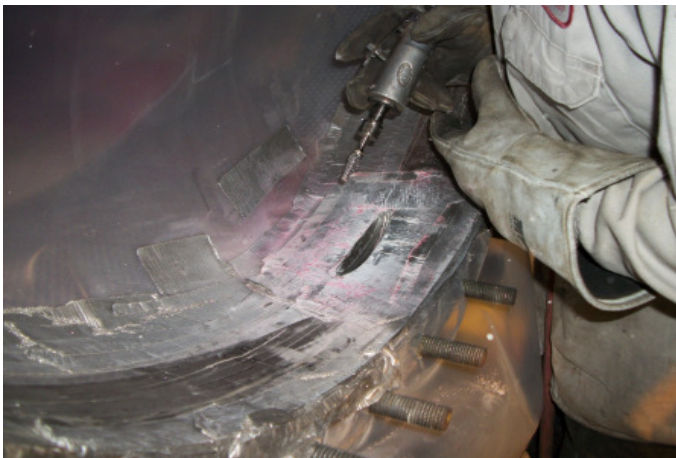
Below illustrates the two cracks found. These areas were prepolished prior to Metal Surgery arriving.

After all areas were protected surrounding the two cracks, the cracks were then excavated. The dye penetration test was repeated many times to make sure the crack was completely excavated.

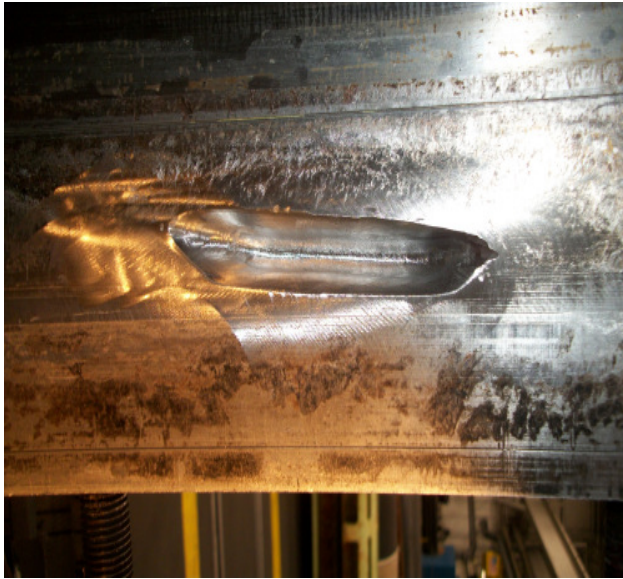
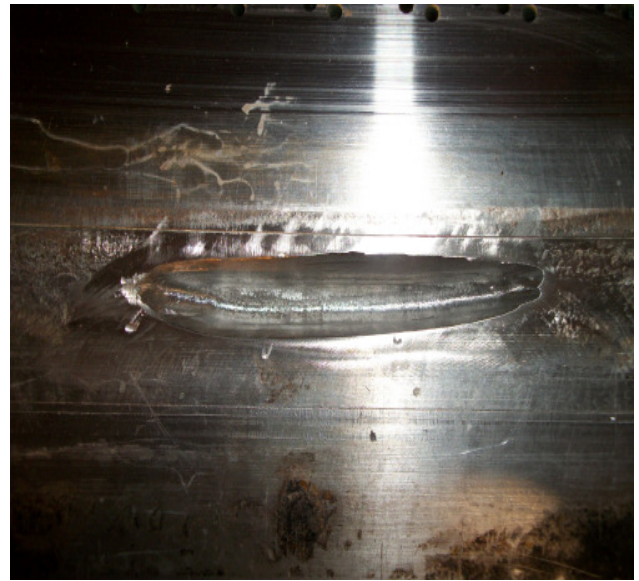
Areas being completely excavated the roll was then prepared for welding. Surrounding areas were taped and blankets placed over the tape to protect the roll's coating from the heat.

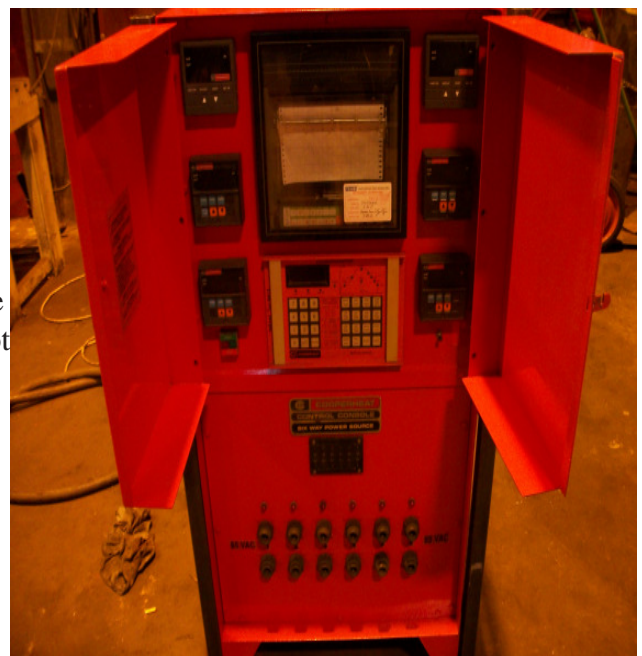
The cooper heat machine to the right was used to monitor temperature to make sure the part was not getting to hot. Many times welding was stopped to let the temperature cool down. This was important for two reasons. The special coating on the roll could only stand up to a certain temperature as well as the procedure and material. Getting to hot will cause many problems in this material which can't be fixed.

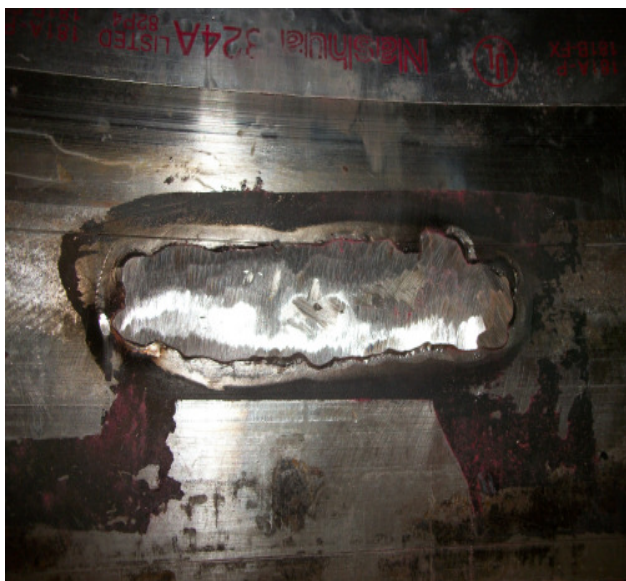
On the right illustration is welding almost complete on one crack. Hand held pyrometers were also used to watch the temperature.

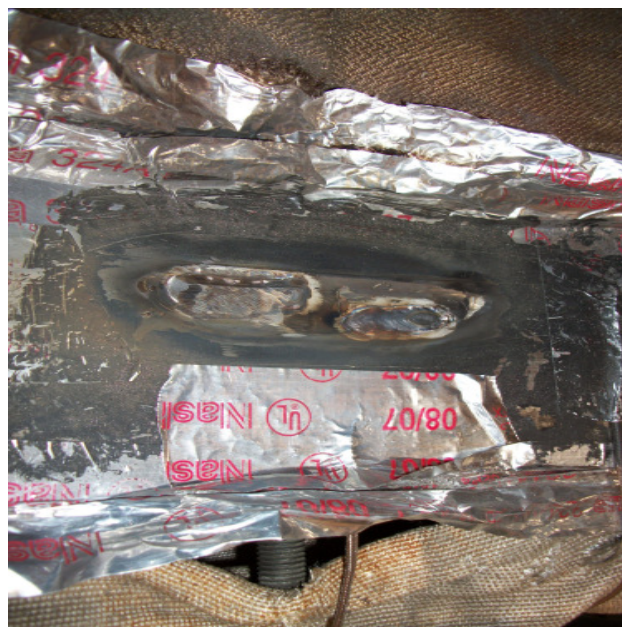
Below is the welding complete and the weld being ground down for final hand finishing.

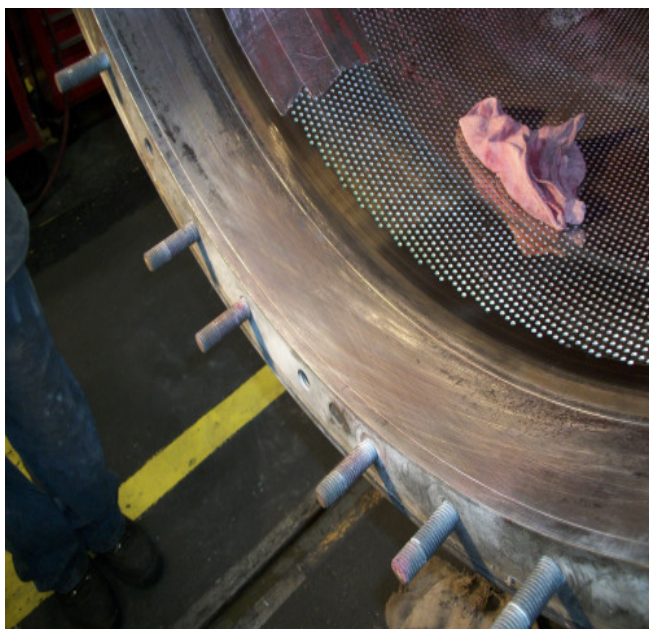
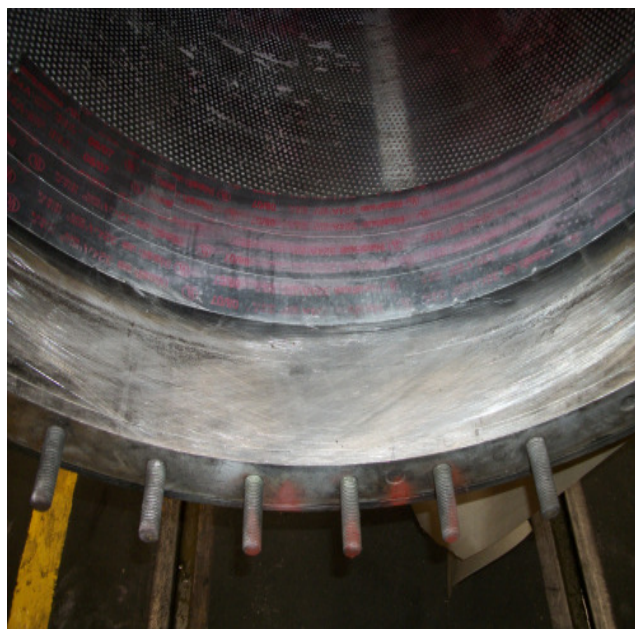
Below illustrates hand finishing complete and the roll ready for production once again.
