Metal Surgery Milwaukee LTD.

Shaft Repair- On-site

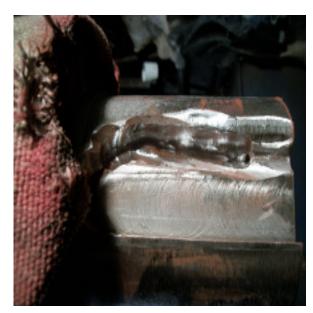
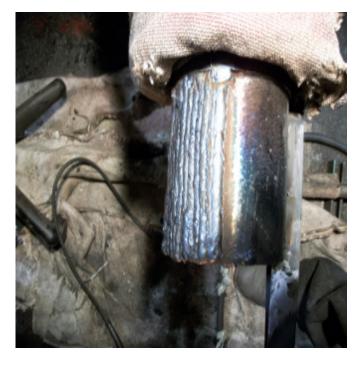
Upon further inspection by crack detection methods, Metal Surgery found that the Keyways were cracked. Metal Surgery then proceeded to excavate the cracks and prepare the shaft for welding cracked keyways and shaft complete. Then the shaft was welded by procedure.

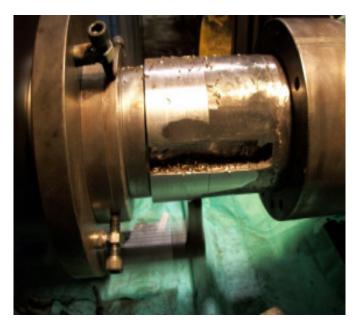
After the shaft was welded, postheat treatment and slow cooled, Metal Surgery then machined the shaft and keyways back to specifications. This shaft was machined without rotation.

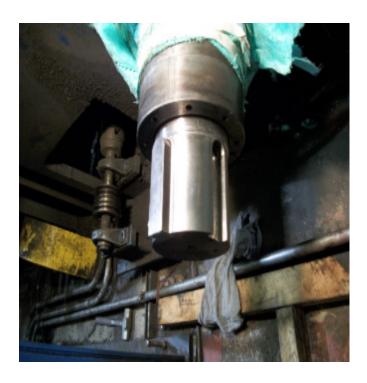
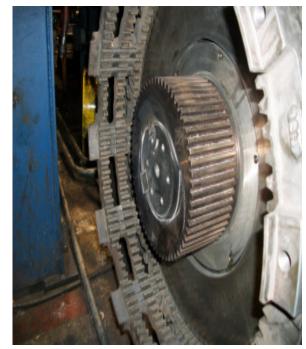
The shaft was finished just ahead of schedule, allowing production to resume on time. The finish pictures below show the finish product in new condition. The quality provided by Metal Surgery is top notch. We warranty all repairs for 1 year from the date the part is put back into service.
