Metal Surgery Milwaukee, LTD.

Pinion Gear Repair

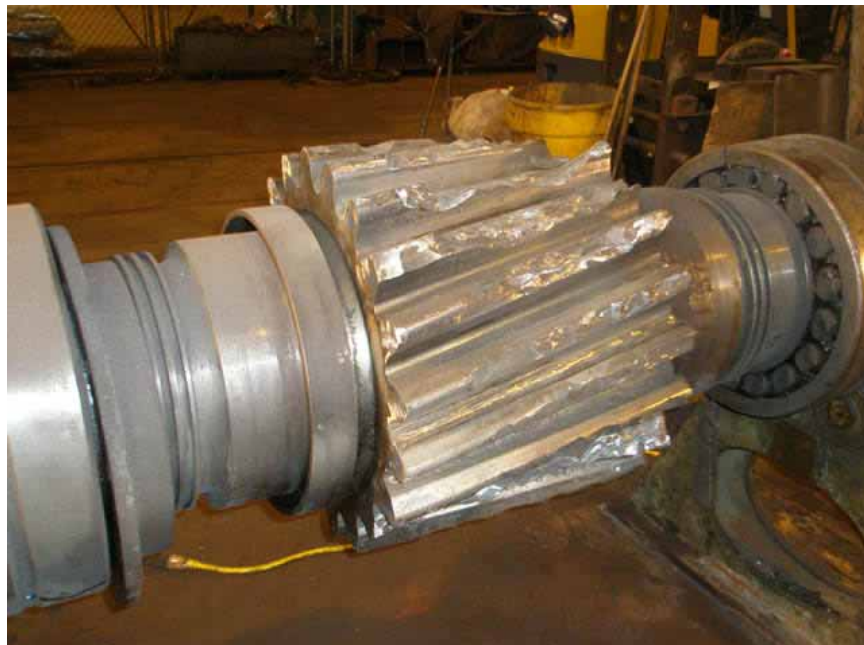
Pinion Gear Assembly

Gear failed during production. (No spare, EMERGENCY repair)
Disassemble pinion assembly, repair teeth by welding, machine and hand finish teeth; and reassemble.

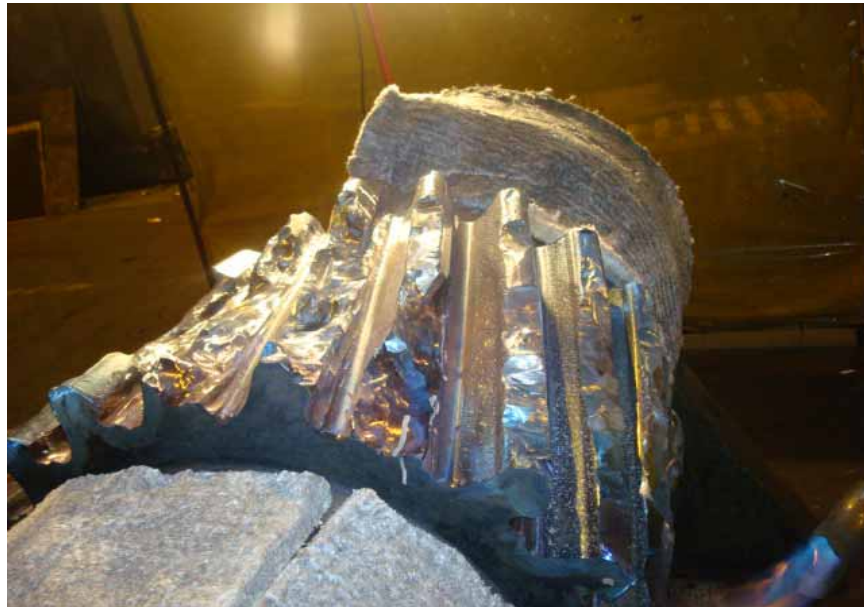
After all the cracks were removed, there were not many teeth left. The base material was analyzed and a weld procedure was produced.

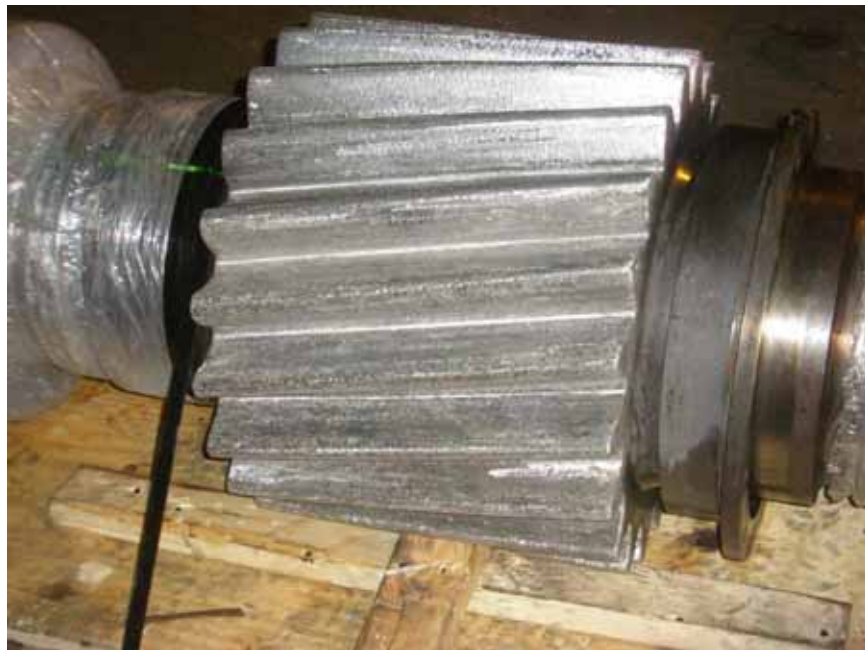
This gear was then hand finished using special gauges and templates. Complete inspection showed no defects and tooth location and size almost perfect.
