Metal Surgery Milwaukee LTD.

Kiln Gear Repair 19'6"

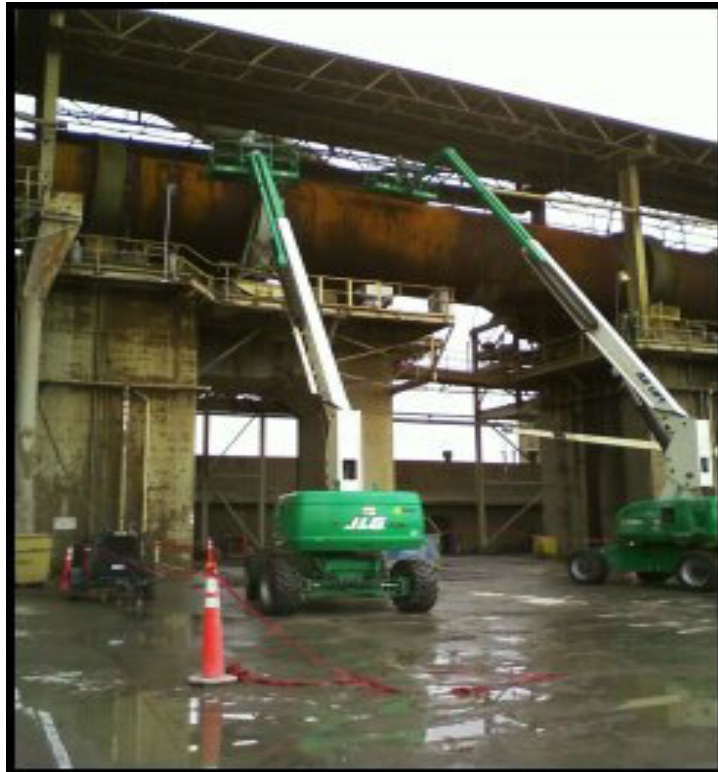
The main rib was cracked in half. This view shows the location of the crack and approximate size of the rib is 6 inches wide at the bottom and 5 3/4 inches in height.

This repair took place on top of the kiln approximately 70 feet from ground level utilizing the high lift baskets (See page one illustration). We worked around the clock and completed the repair in approximately three days.
