ELECTRIC SALES AND ENGINEERING ELECTRIC MOTOR ROTOR SHAFT JOURNAL

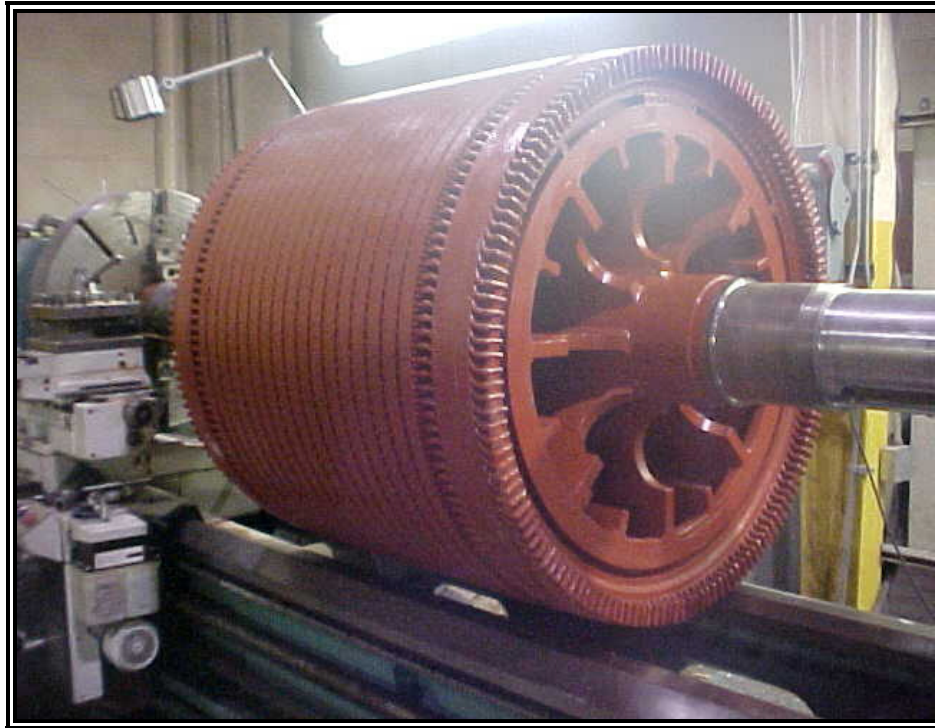
Bearing journal damaged after years of service. Plating is the best repair procedure on an assembled stator. There is no heat involved with this process assuring no damage to assembled unit. Using flow-thru anode, chemicals are pumped through a carbon while shaft is in rotation.
