Metal Surgery Milw. LTD 10/19/02

Tembec Canada
Inspection & Repair Report of
AC. Compressor Valute

A.C. Compressor Valute

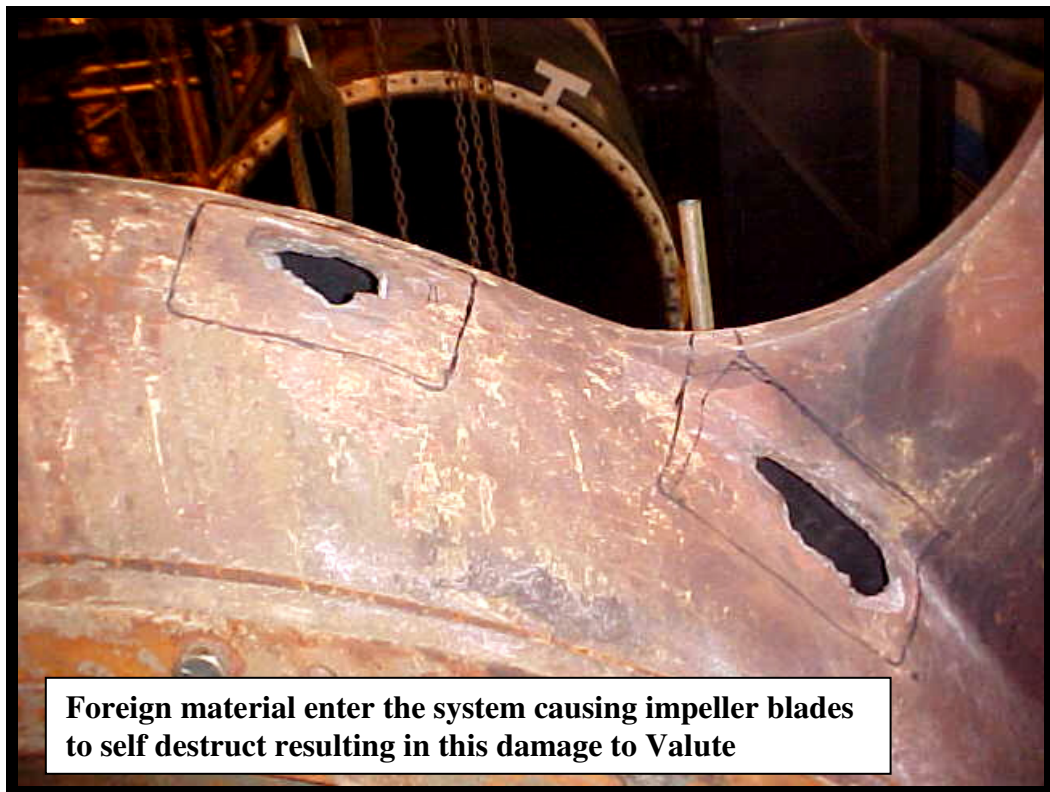
Foreign material enter the system causing impeller blades to self destruct resulting in this damage to Valute
